## A Survey of Thatched Buildings in Scotland

Thatch Survey of Scotland  
2014-15

A photographic survey of thatched buildings in Scotland, surveyed between May 2014 and August 2015 by Zoe Herbert (SPAB Scotland Officer), on behalf of the Society for the Protection of Ancient Buildings.

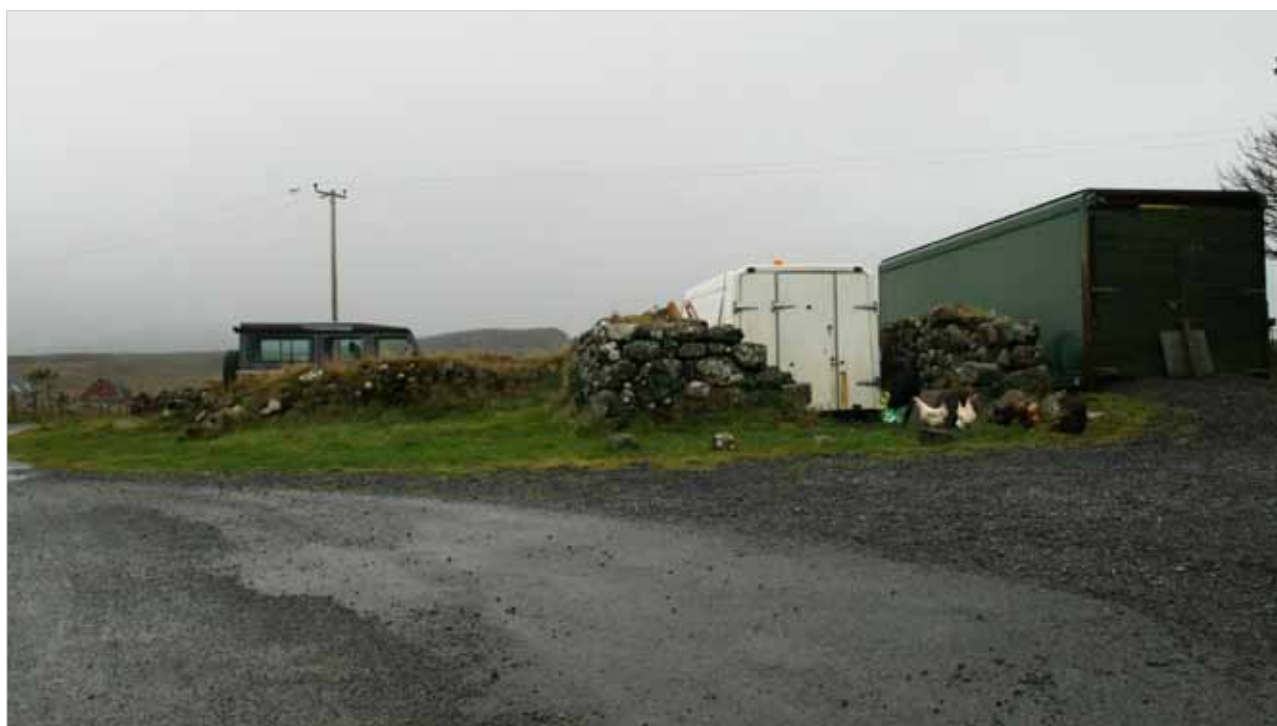
**Additional Notes:** ..... The listed building description reads 'Later 19th century, traditional Skye dwelling of long-house type. Single storey. Thick, battered walls, piended thatched roof'. The listing notes read 'now used as byre and for hens'. All buildings at this location are now ruins and no visible evidence of any roof structure or thatch remains. The ruins are currently being used to store vehicles and their walls reach only a few feet off the ground. The listing description should be updated accordingly.

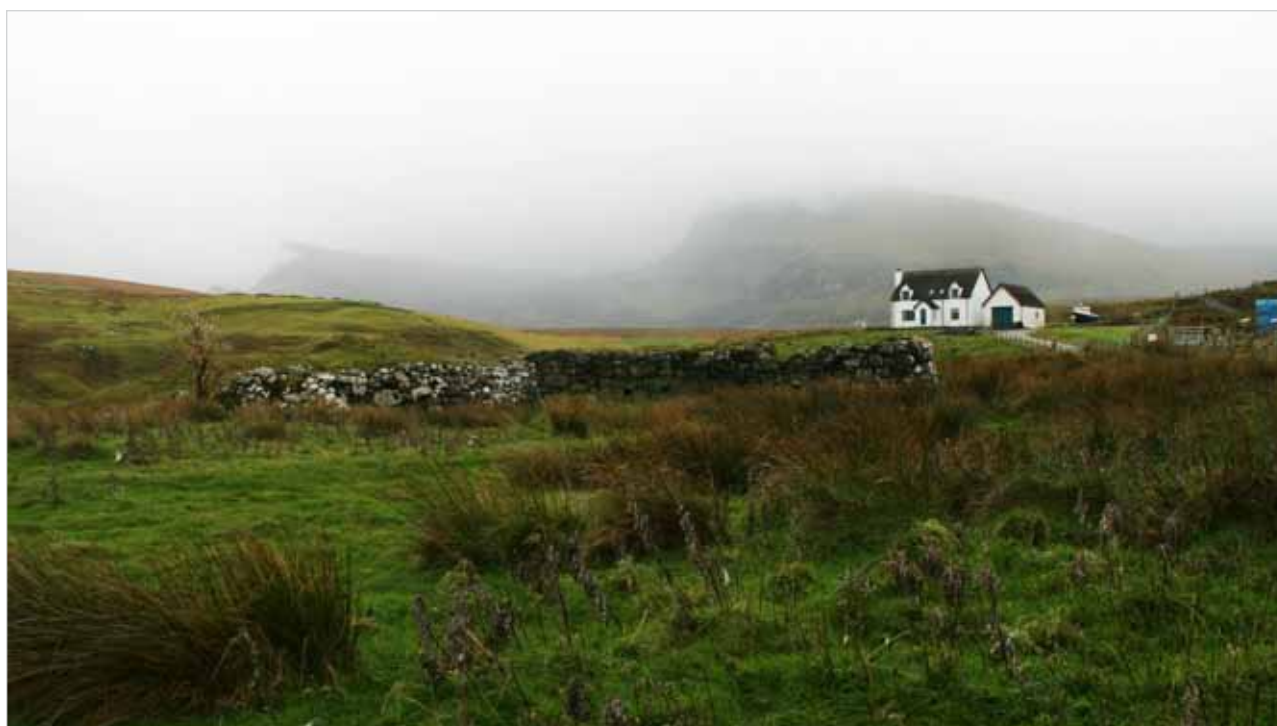
**Additional Notes:** ..... Pair of byres, listed in 1982 as being thatched and noted as being 'in use'. The listed building description reads '19th or early 20th century, pair traditional Skye byres, one single bay, one 2 bay. Rubble, round corners, piended thatched roofs'. Both byres are now roofless ruins, their walls reaching only a few feet from the ground. No visible evidence of any thatch or roof structure remains. The listing description should be updated accordingly.

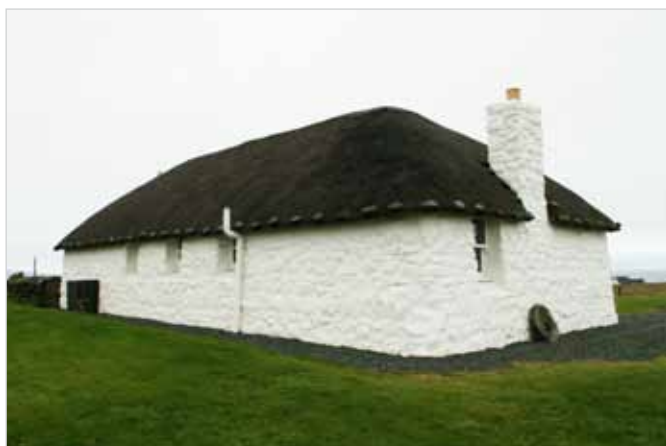
Additional Notes: ..... Single-storey thatched cottage, currently in use as a holiday let. The website advertising the property states that the building was restored by architects Rural Design, who are based on the Isle of Skye. The website also states that the building is a 'restored blackhouse' that was originally built by the church as a reading room. The reed-thatched roof, with continuous thatched ridge, is entirely netted and is weighted by stones along the eaves and around the chimney stacks. The stones are secured to the wire netting using metal wire.

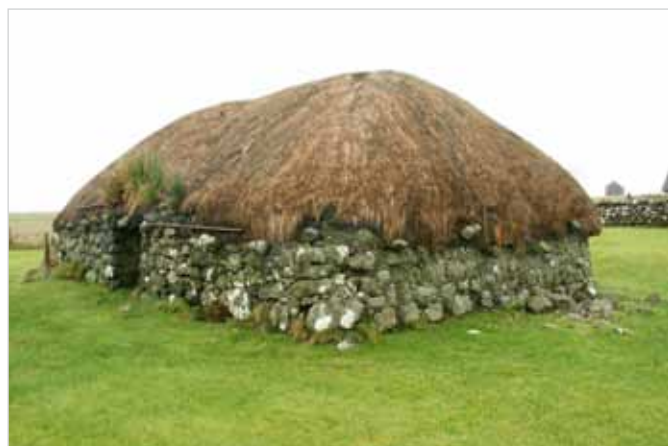
building a metal pole has been used to weigh down the netting at the eaves, onto which some of the stones

have been tied. There is a small amount of vegetation growth across the surface of the thatch, particularly above

one of the door openings, where there is a large

patch of grass growing from the thatch just above

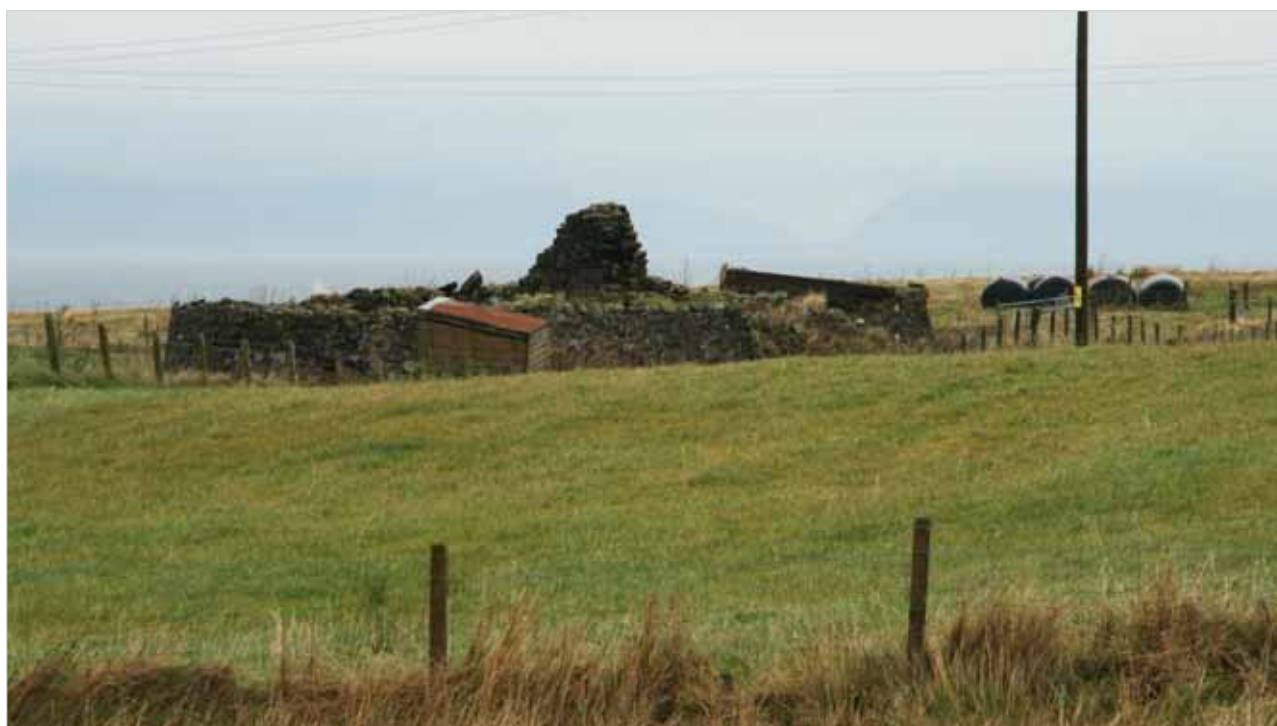
**Additional Notes:** ..... The listed building description for this building reads '*Traditional 19th century Skye house; rubble, rounded corners. Long elevations roughly SW and NE. Single storey, 2 long bays with entrance at right. 2 windows rear. 2 near centre ridge chimney pots; piended thatched roof.*' When it was listed in 1971 it was noted as being '*lived in*'. The building is now a ruin and no visible evidence of any roof structure or thatch remains. The listing description for this building should be updated accordingly.

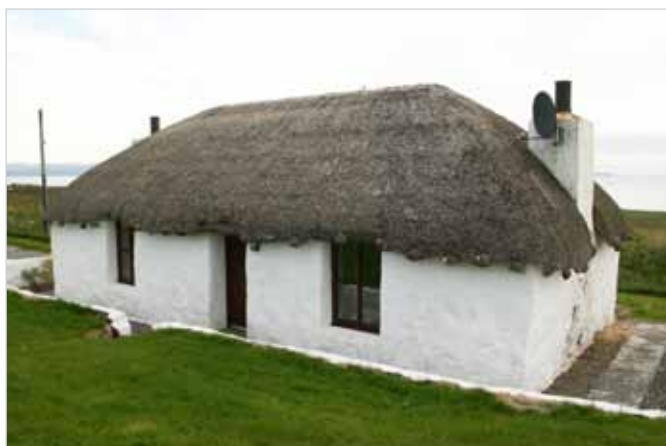
a few patches of mossy vegetation growth across

the surface of the thatch, but this is not extensive.

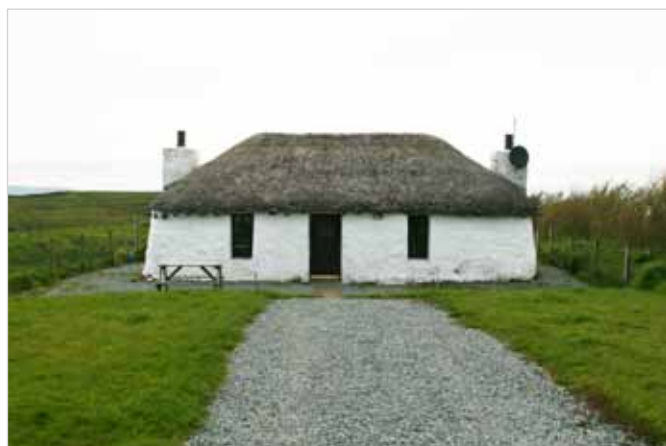
**Additional Notes:** ..... Modernised thatched cottage, currently let out as holiday accomodation. The roof is thatched in what appears to be either reed or straw and has a continuous thatched ridge. The ridge has a single row of horizontal scobing made from metal. The entire roof has been netted, using a particularly large gauge wire net, which has been weighted along the ridge using stones secured to the netting by wire. In some places, the thatch has deteriorated somewhat and where this is particularly bad, additional wire netting has been placed horizontally across the thatch to try and keep the thatch in place. In addition to some of the thatch being loose

..... in places, the thatch has also compacted in others.

..... There is also a small amount of mossy vegetation growth on the surface of the thatch in places; however, this is not extensive.

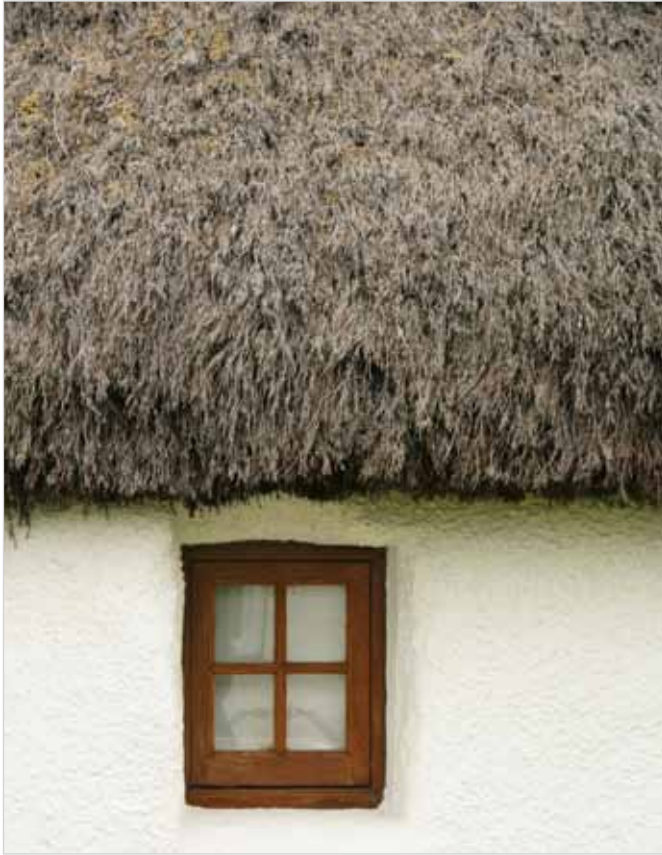
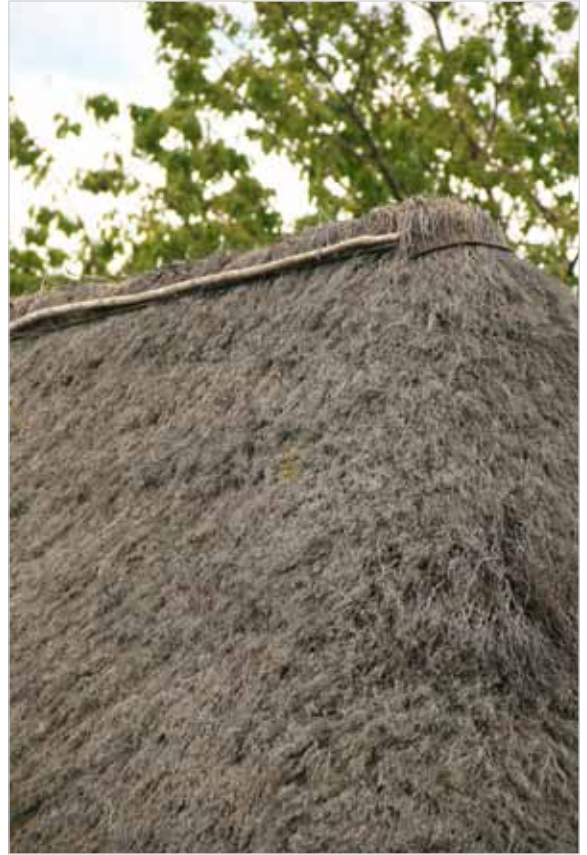
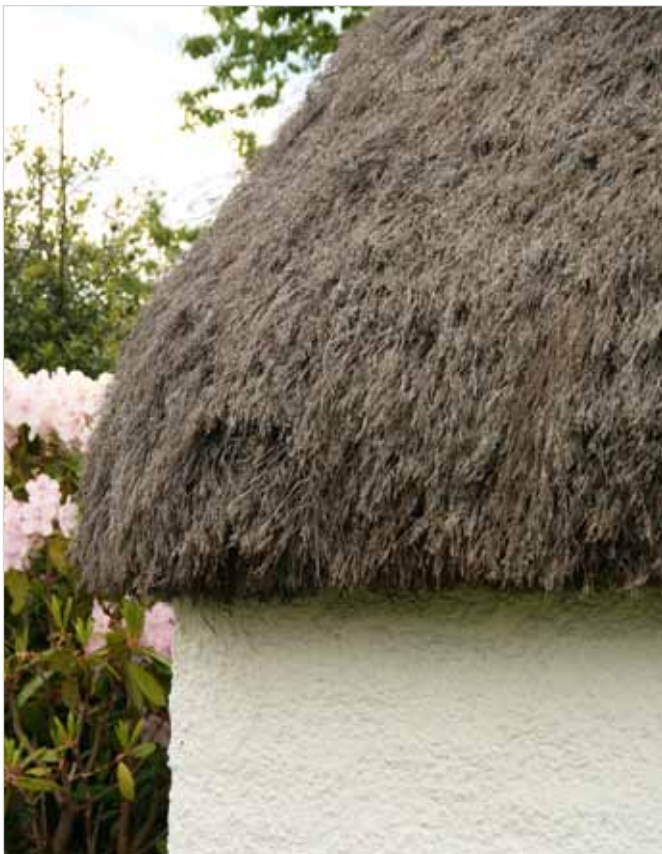
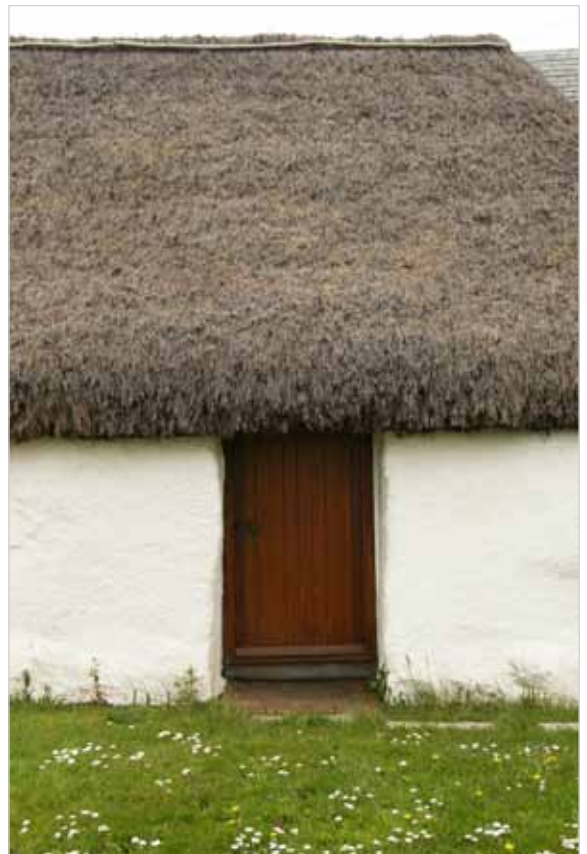
Tulloch Ard – Highlands

Condition of Thatch: ..... Good

Additional Notes: ..... 19th-century single-storey house, listed as having a '*piended heather thatched roof*'. The roof is thatched in heather continuously across the ridge, which has then been secured by a single horizontal metal wire that has been pegged to the ridge with wire. A single row of branches has been secured over the wire to cover it and to delineate the ridge. The thatch has not been netted anywhere.

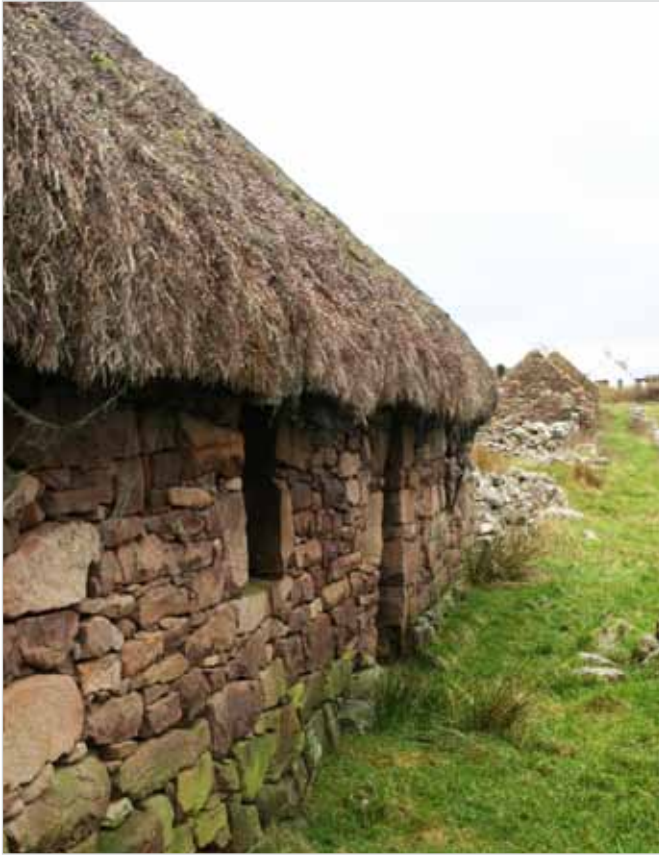
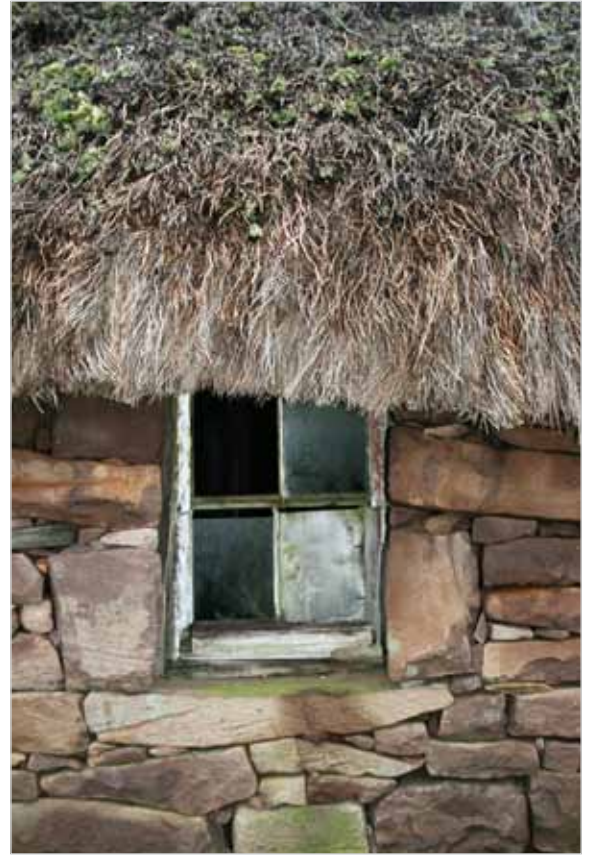
Lonbain Thatched Cottage – Highlands

Additional Notes: ..... Early to mid 19th-century single-storey cottage, the sole surviving thatched cottage in Lonbain, a linear settlement of cottages, the rest of which are in a ruinous condition. The cottage is listed as having a 'pegged turf N gablet [and] straw thatched roof' however there are no signs of any turf gablet and the roof is currently thatched in heather. The heather thatch is continuous across the ridge and the entire roof is netted, with net of various gauges. There is a large amount of mossy vegetation growth across the surface of the thatch throughout and the surface of the thatch is slightly uneven in places. There are no chimney stacks, but 'clay

..... Fair

*drainpipes project at each rounded apex to serve as flues'. The building appears to be derelict and currently without use; however, the National Trust for Scotland, who have recently purchased the building, have commissioned a Conservation Plan as part of their plans to conserve and consolidate the site. N.B. Scheduled for complete re-thatch and structural repair in Spring 2016.*

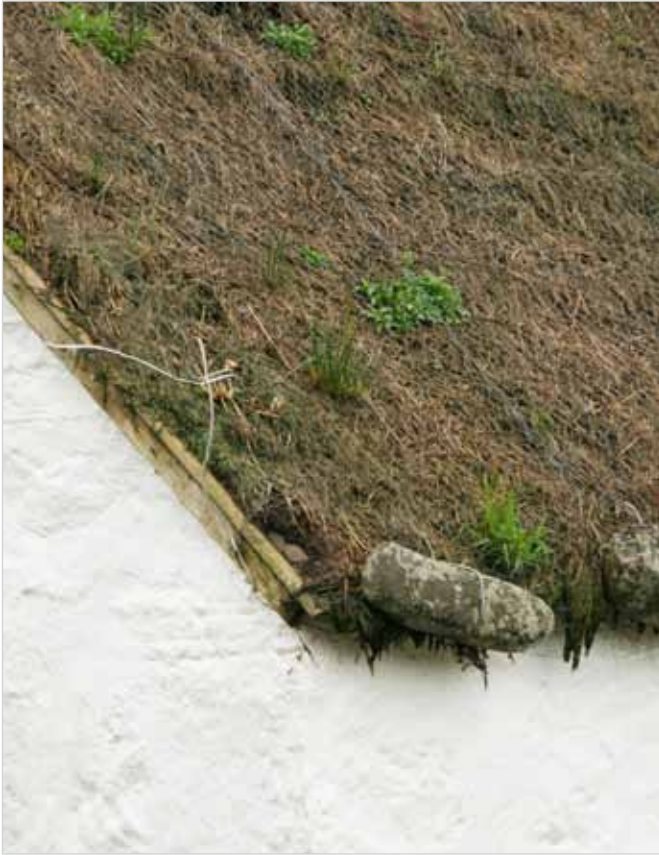
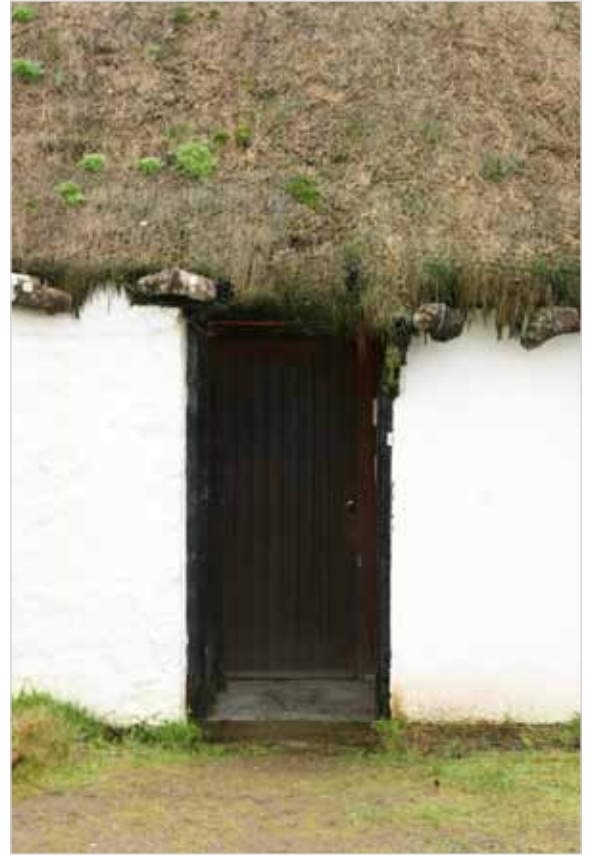
Giant Angus MacAskill Museum – Highlands

Condition of Thatch: ..... Poor

thatch is missing in a few patches across the roof, particularly down the skewes and along the ridge, exposing

what appears to be timber and a corrugated roof covering. Underneath the missing thatch along the ridge,

missing throughout, exposing the roof structure

underneath.

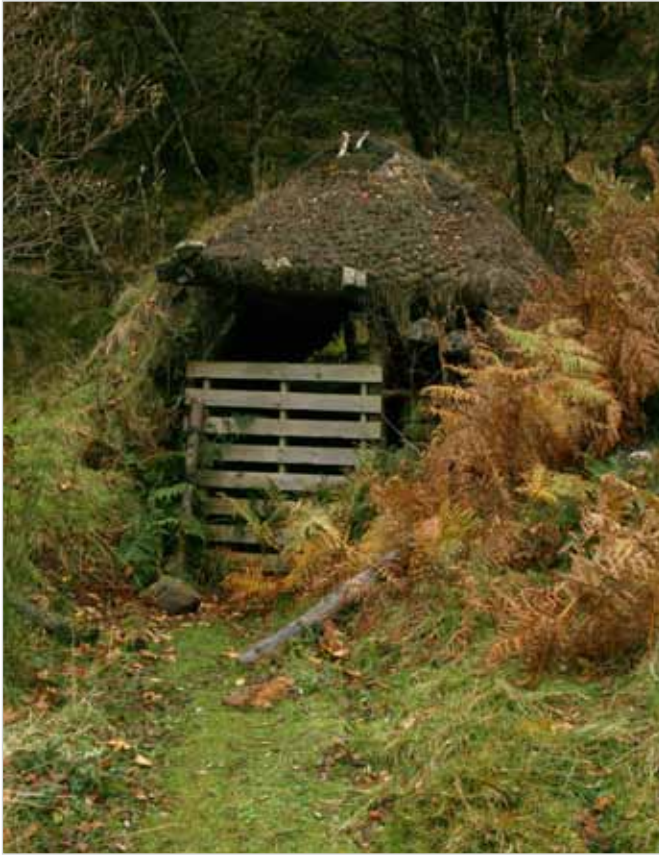
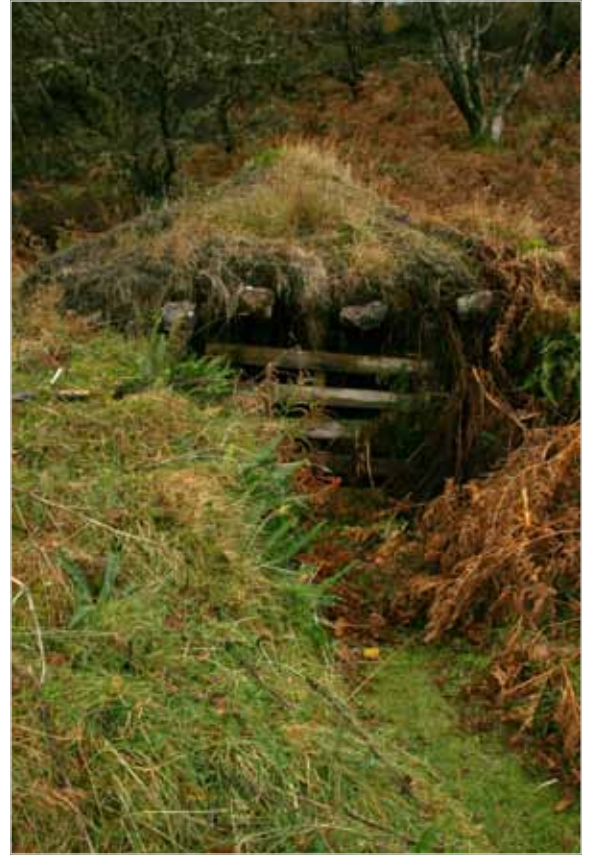
Colbost Croft Museum – Highlands

Condition of Thatch: ..... Fair

**Additional Notes:** ..... Late 19th-century croft house listed with former still behind the house. Additionally, there is an outbuilding a few metres away from the still, which was supposedly used as a store. All buildings now form the Colbost Croft Museum, which was established in 1969 by local Peter MacAskill, who also established the Giant Angus MacAskill Museum in Dunvegan. The cottage is thatched in what appears to be either rush or marram, and appears to currently be having another layer of thatch installed as a top coat. The ridge is thatched continuously across, and the entire roof has been netted. The netting has been weighted down at the eaves using

stones, secured to the netting with wire. There is a fair amount of vegetation growth to the surface of the thatch, particularly along the front elevation, which also has an amount of algae-type growth on the thatch. The thatched roofs of the outbuildings, which appear to be thatched in the same manner, are heavily overgrown with vegetation.

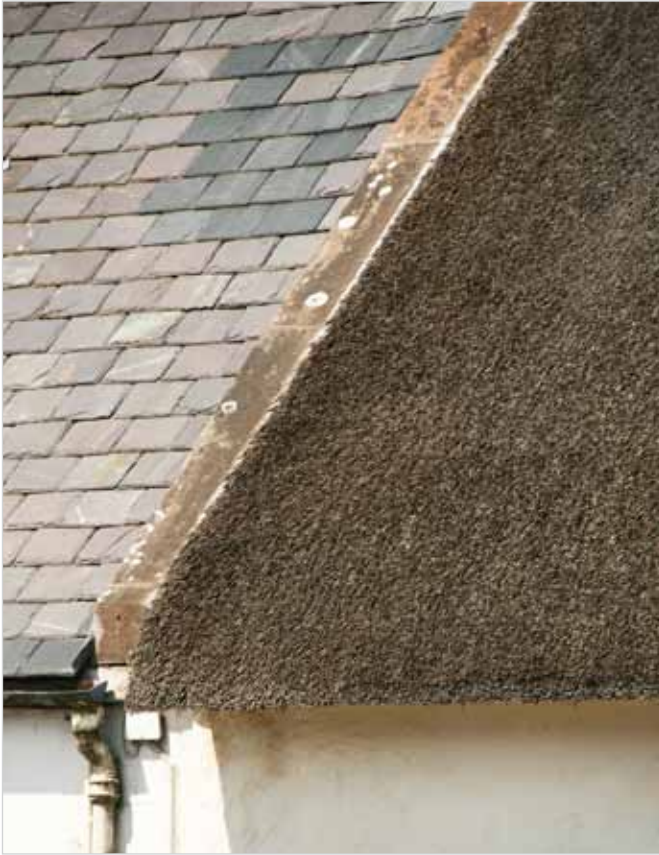
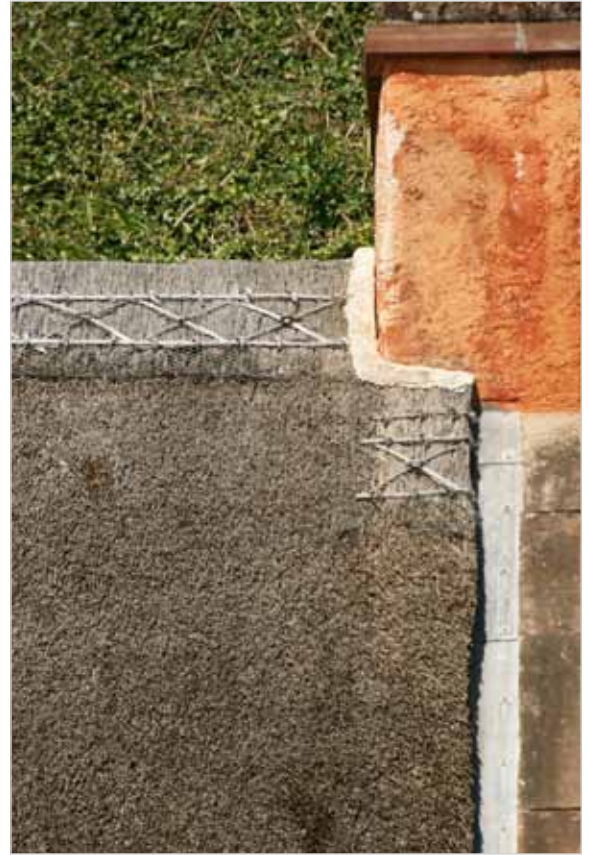
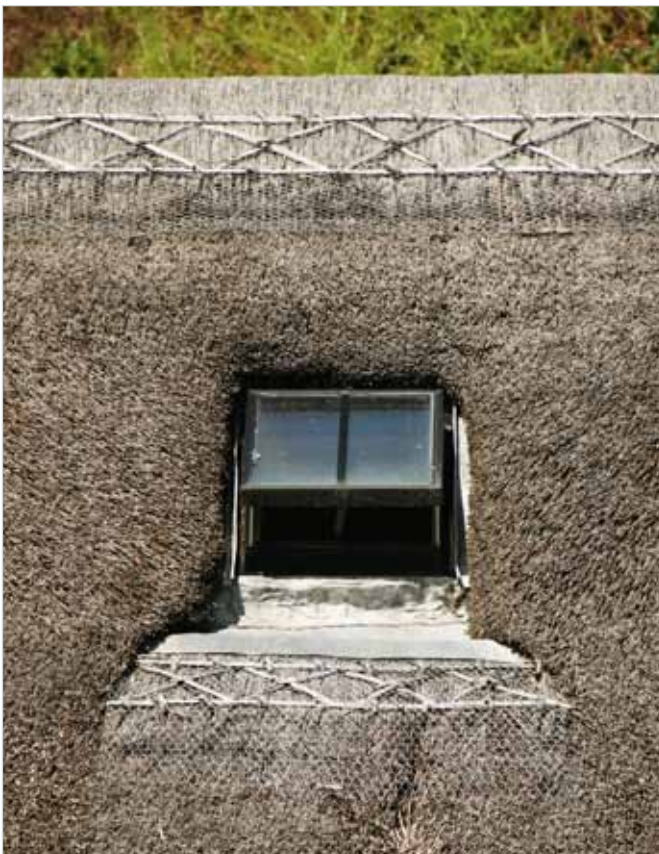
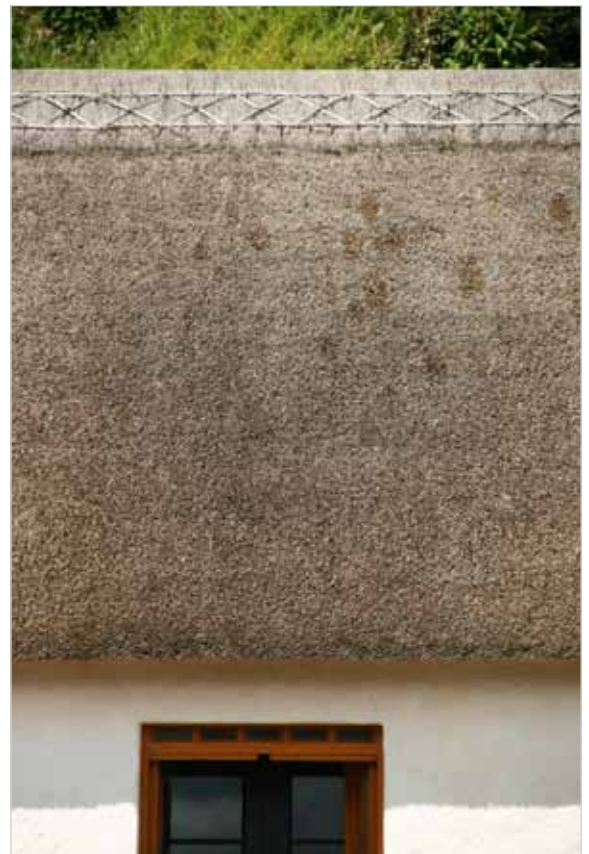
Rye Cottage – Highlands

Thatch Type: ..... Reed  
Ridge Type: ..... Thatched (Reed)  
Condition of Thatch: ..... Good

Additional Notes: Group listing of two late 19th-century cottages, the one at 29 High Street listed as having a slated roof, and that at number 30 listed as having a corrugated iron roof. The cottage at number 30 now has a reed-thatched roof but whether there was thatch underneath the corrugated iron at the time of listing is unknown. The building was restored and used as a holiday let in the last couple of decades and appears to have had a completely new roof covering installed at this time. The ridge of the roof, which is slightly raised, has been scobed using hazel spars. There are two attic windows on the front elevation, and the thatch below these openings

has also been scobed with hazel spars, as well as a small patch of scobing underneath the chimney stack at the north east gable end. The roof has been netted along the ridge and over the patches of scobing only, while the rest of the thatch has been left uncovered. The listing description should be updated accordingly.

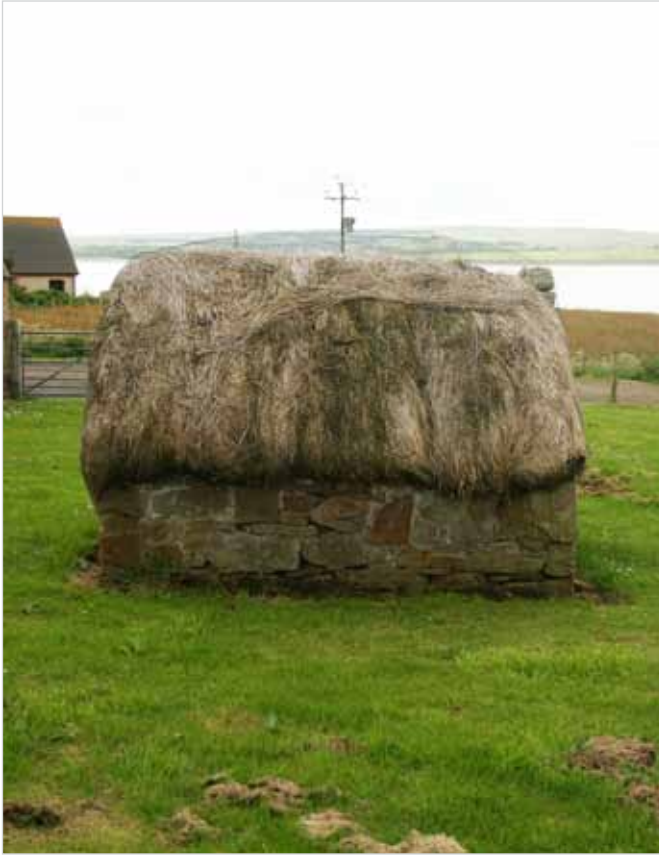
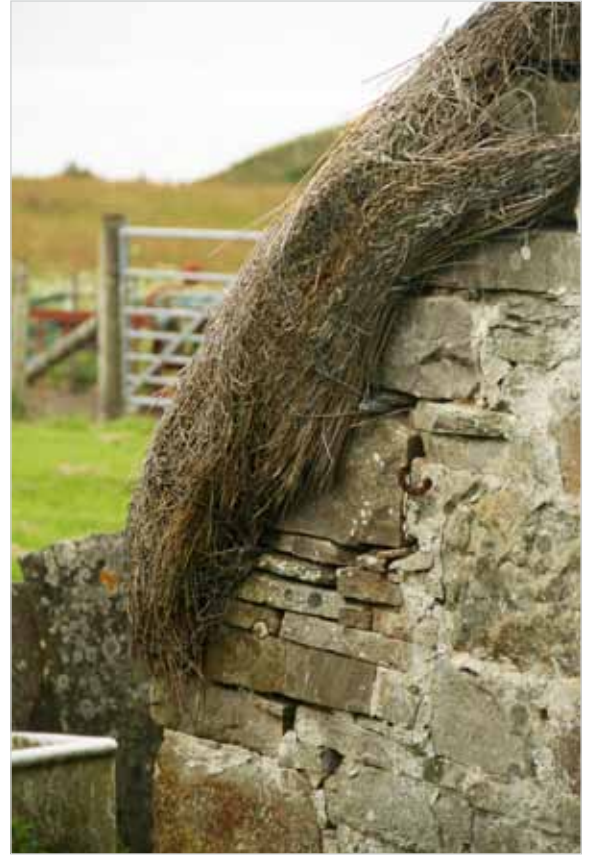
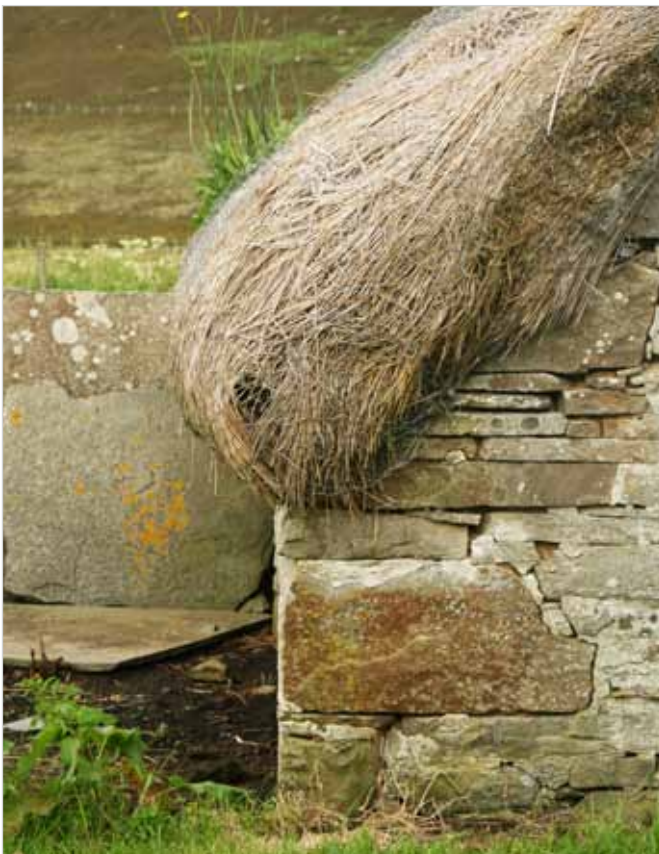
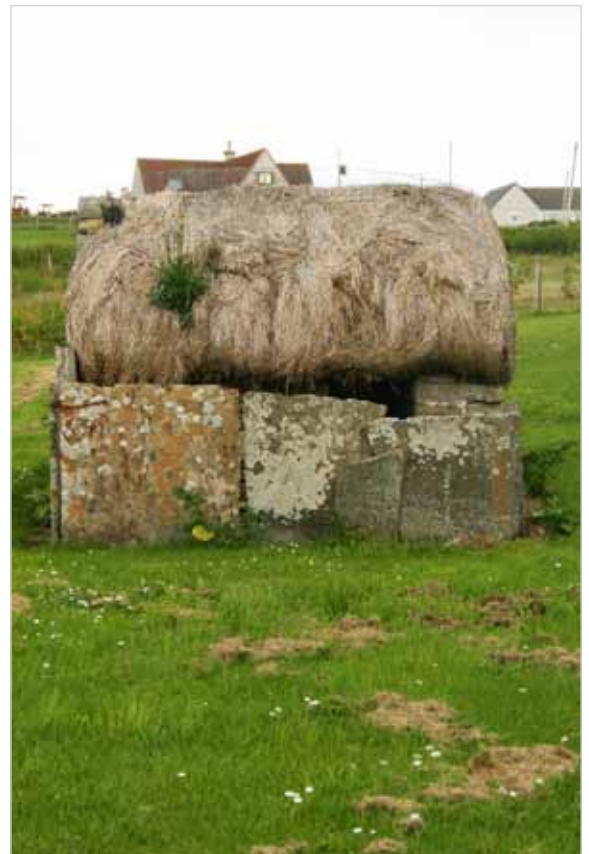
West Side Croft – Highlands

Group listing of a mid to late 19th-century croft house, with adjoining outbuildings and detached pig house and privy. The croft is also known as Mary Ann's Cottage, after the last owner and occupier of the buildings, and is now open to the public as a museum. Only the pig house is listed as having a thatched roof, which is currently thatched in marram. The small structure has a continuous marram ridge, and the entire roof has been netted, including over the ridge. The netting has not been weighted in any way; instead it has been nailed into the mortar joints along the gables but left unsecured along the eaves. The netting along the ridge is slightly higher

than the thatch, indicating that the thatch may have experienced some compaction. There are a few patches of grassy vegetation growth across the surface of the thatch, as well as an algae-type growth across the surface of the rear elevation.

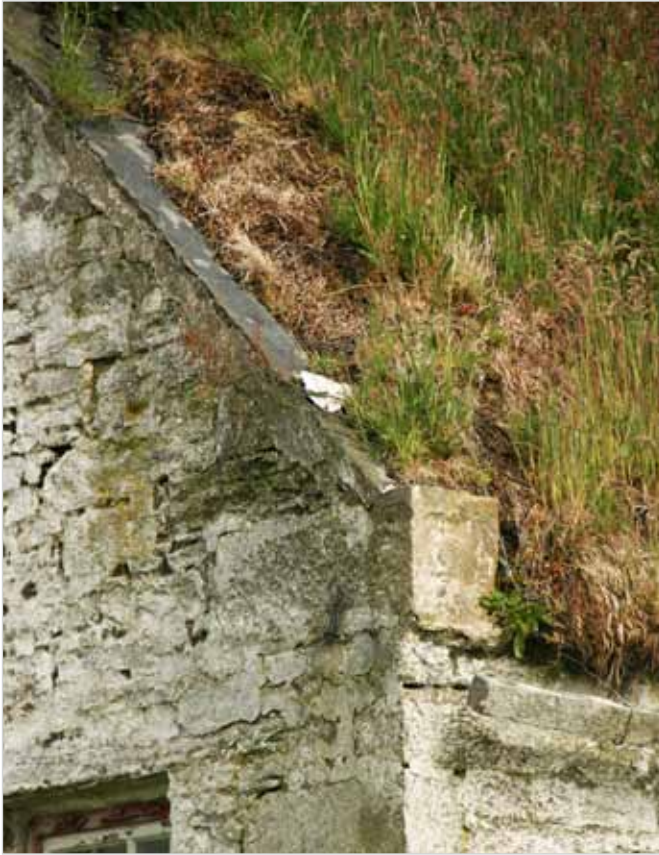
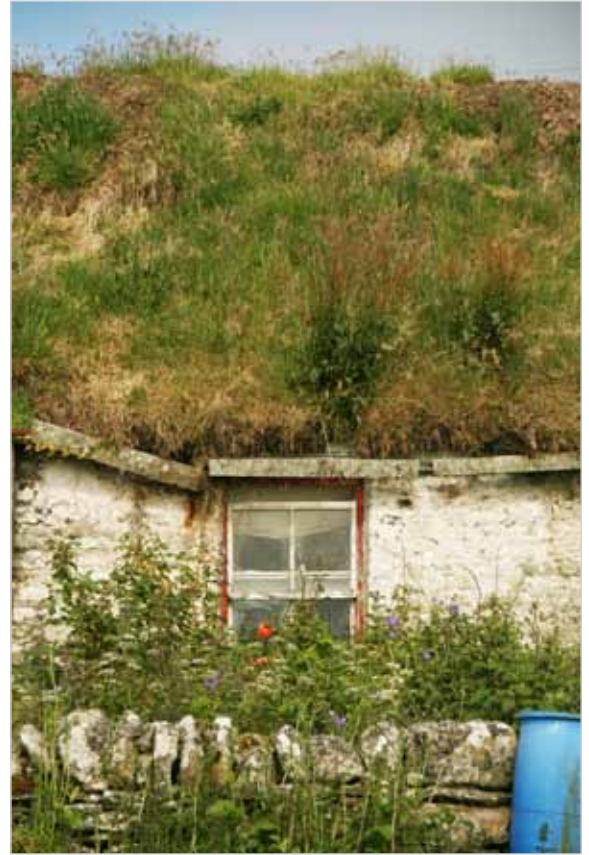
Mr James Sinclair's House and Steading – Highlands

Thatch Type: ..... Rush  
 Ridge Type: ..... Thatched (Rush)  
 Condition of Thatch: ..... Poor

Additional Notes: Mid 19th-century house with steading at a right angle to the north. Both the house and steading are listed as having a 'rush thatched roof'. According to the listing notes, the owner who lived there at the time of listing, Mr James Sinclair, was a thatcher who re-thatched nearby Laidhay Croft Museum in the 1970s. The steading to the north is now a ruin and the thatched roofs have collapsed. The house retains its rush-thatched roof; however, it is heavily overgrown with vegetation and the building is vacant. The roof is entirely netted, and weighted at the eaves with long stone slabs secured to the netting with wire. A few of the weighting stones have become dislodged and slipped partially.

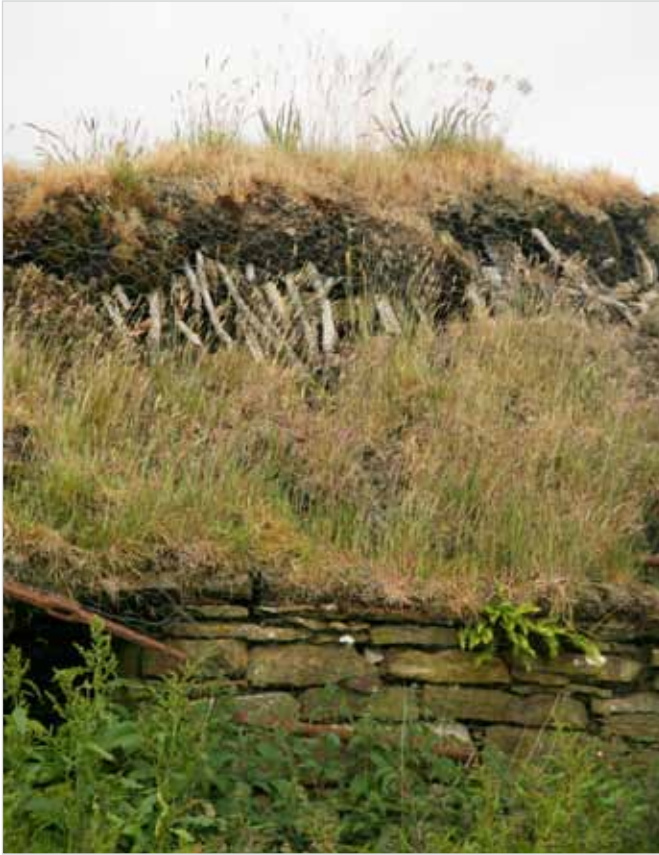
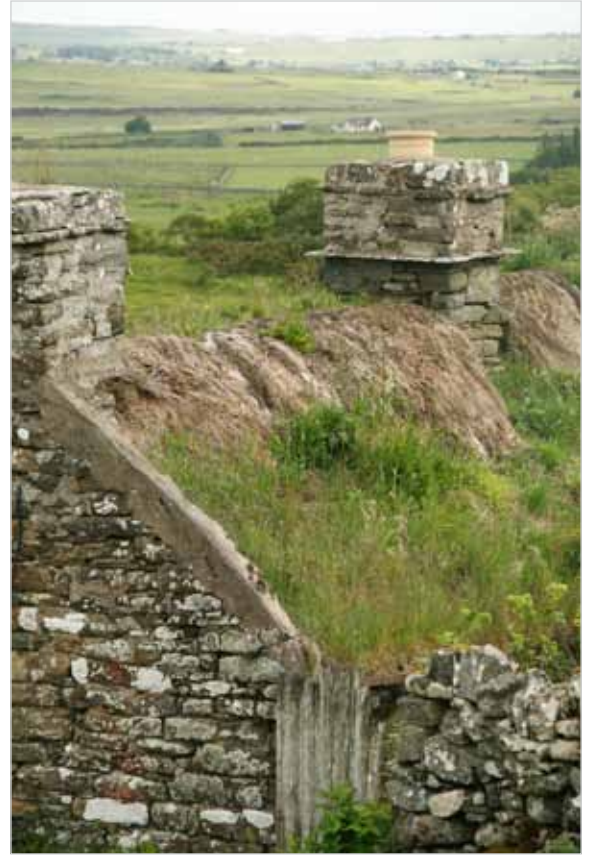
The Corr – Highlands

Address: ..... The Corr  
..... Latheron Listing Category: ..... C  
..... Wick Date Listed: ..... 28/11/1984  
..... Listed Building Number: ..... 7935  
Local Council: ..... HIGHLANDS Canmore ID: ..... 93288  
Building Type: ..... Croft Complex  
Use: ..... n/a  
Grid Reference: ..... ND 20250 35707 Occupancy: ..... Derelict  
Date of Visit: ..... 13/07/2015 Buildings At Risk: ..... Yes  
Thatch Type: ..... Rush  
Ridge Type: ..... Thatched (Rush)  
Condition of Thatch: ..... Poor

**Additional Notes:** Early 19th-century croft complex, consisting of longhouse, byre, barn and stable range, hen house, wash house and cart shed. The listed building description states that the dwelling, hen house and workshop range all have rush-thatched roofs. The buildings have been vacant for some years now and have been on the Buildings at Risk (BAR) Register since 2008 (BAR reference number 3623), at which time it was already recorded that the thatched roof was in poor condition and suggested it did '*not appear to have been maintained for several years*'. The roofs of the ancillary buildings to the south west of the longhouse have large

areas of thatch missing, exposing the interiors of the buildings. Part of the longhouse range has been covered with a temporary corrugated iron covering, whilst the section to the west remains uncovered. The thatch that can be seen on the longhouse is heavily overgrown with vegetation.

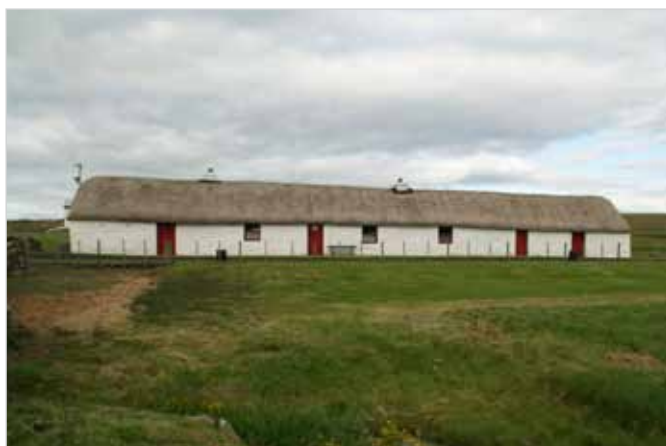
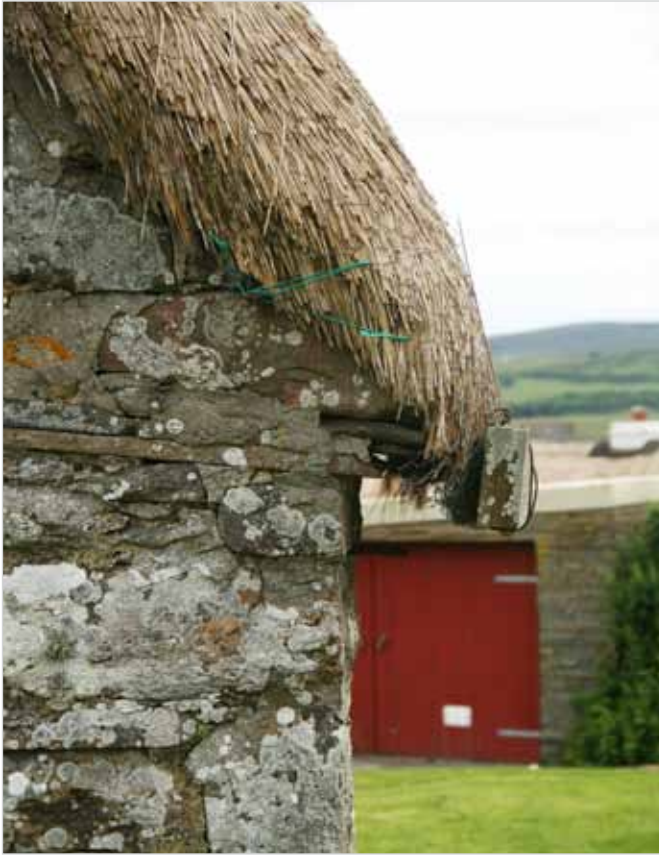
Laidhay Croft Museum – Highlands

..... According to the listing, the building is thatched in rush. It has a continuous thatched ridge and the entire roof has been netted, including across the ridge. The netting is weighted along the eaves with long slabs of stone and concrete, which have been secured to the netting with string and wire. At the gables, the netting has been fixed into the gable wall with metal pegs, and stones have been hung from the netting in places for additional weighting. The

..... building has two chimney stacks along the ridge, around the base of which have been placed tiles of what appears to be turf that is held in place by the netting. There is some minor weed growth on the surface of the thatch in places, but otherwise the roof is in a well-maintained condition.

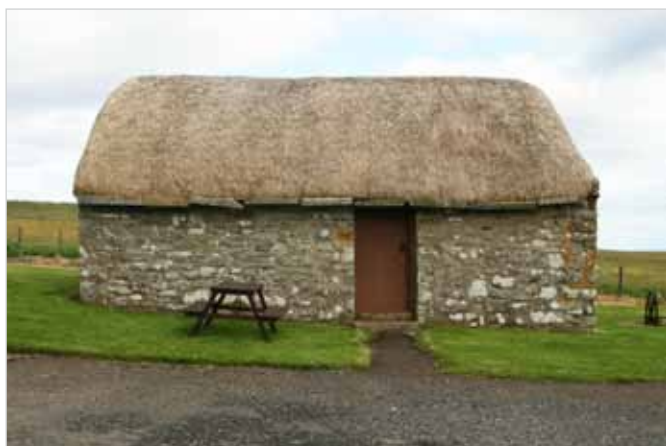
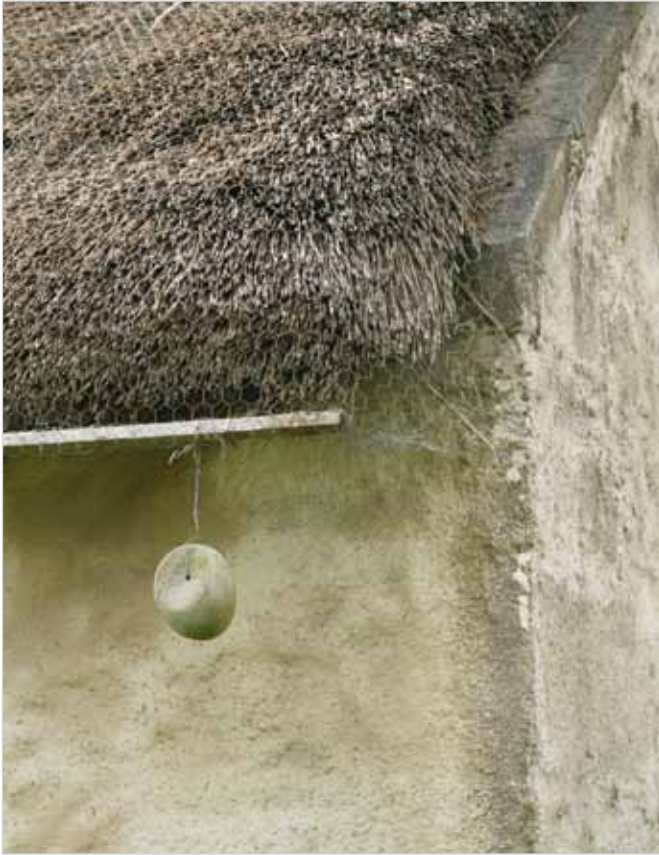
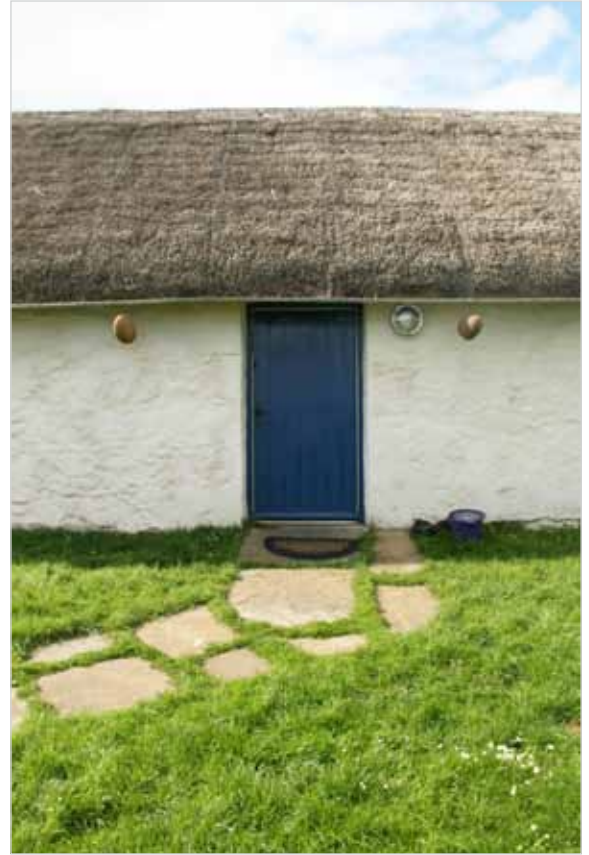
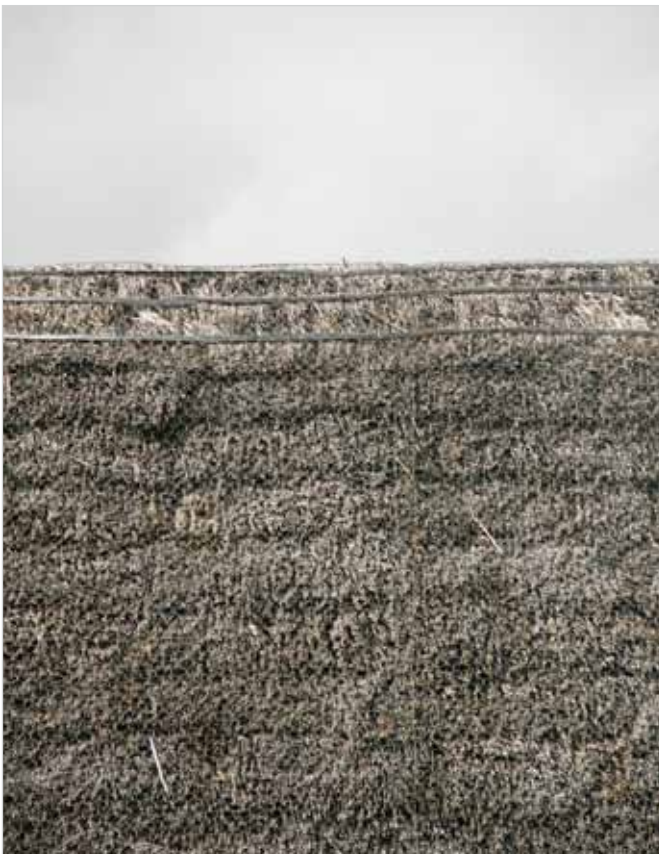
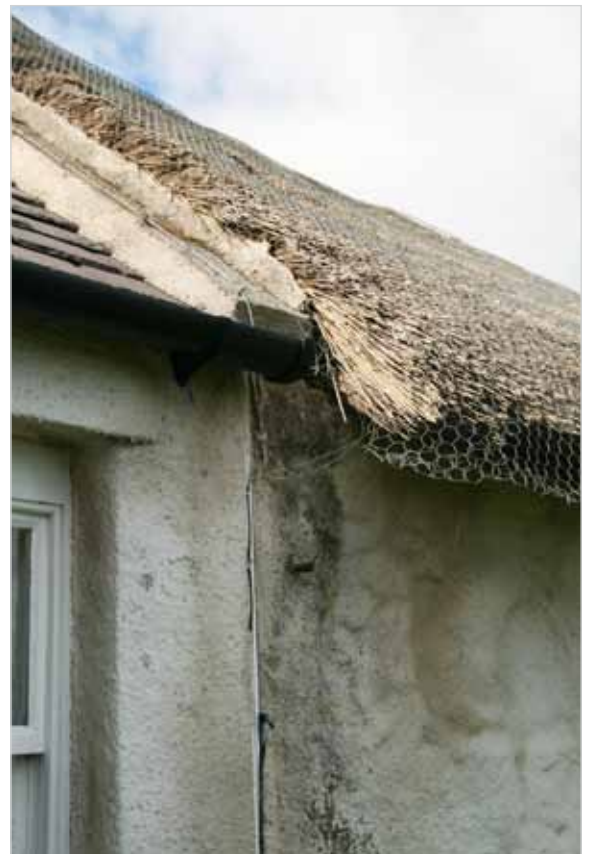
Laidhay Croft Museum Barn – Highlands

..... The building would appear to be used as storage for the museum.
